ASBESTOS INSPECTION REPORT

UNT Chilton Hall 410 Avenue C, Room 111 Denton, TX

Site Location: 410 Avenue C, Room 111, Denton, TX

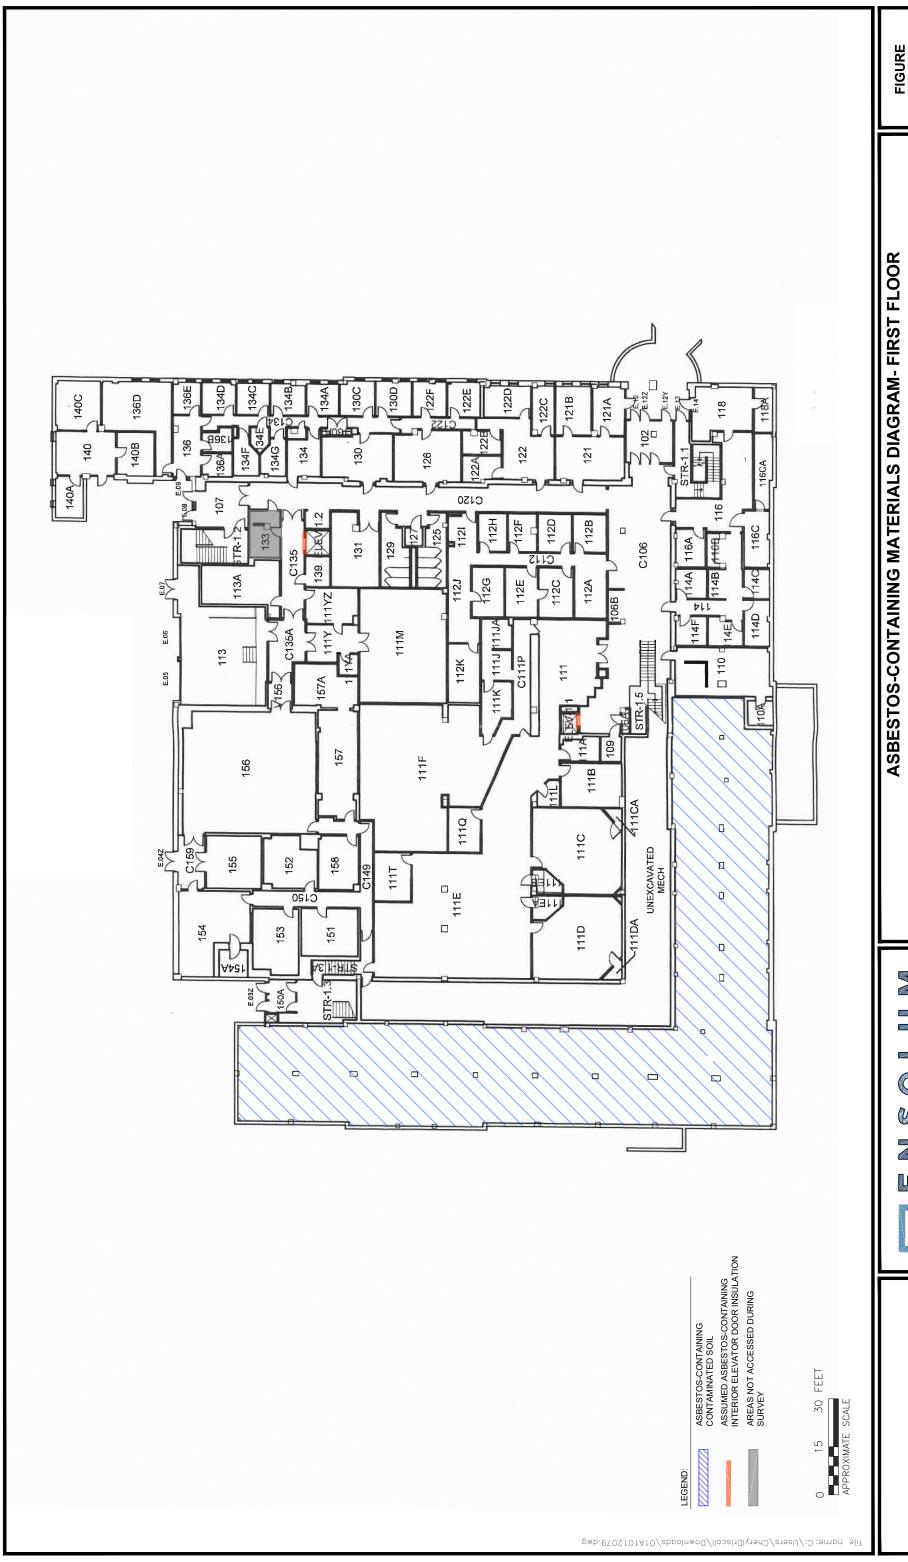
APPENDIX C: Drawings

CHILTON HALL - BUILDING #0126 - UNIVERSITY OF NORTH TEXAS 410 Avenue C
Denton, Texas 76201
